Manhole Inspection Summary

Manhole # S13II_005MH

Location Address: **2831 NORTH AVE** Cross Street: **DUKELAND ST**

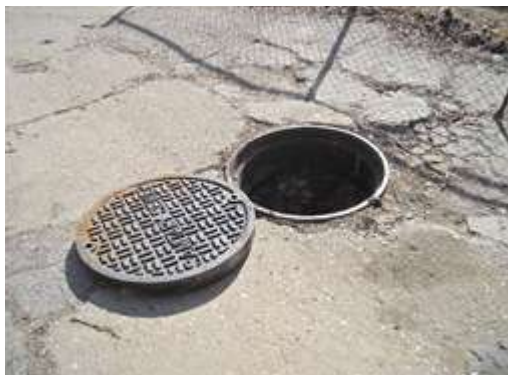
new cover

ARRIVED AND FOUND THAT
PREVIOUS LID WAS FULLY CRACKED
AND BROKEN. REPLACED WITH NEW

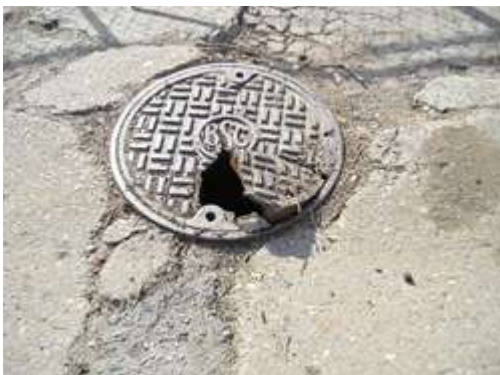
Cover Shape: **Circular** Diameter: **24** (in.) Length: (in.) Dist A/B Grade: **0** (in.)
Type: **Sanitary** Condition: **Broken** Cover Material: **Cast Iron**
Properties: ☐ Bolted ☒ Vented ☐ Water Tight ☐ Water Tight Insert

cover broken

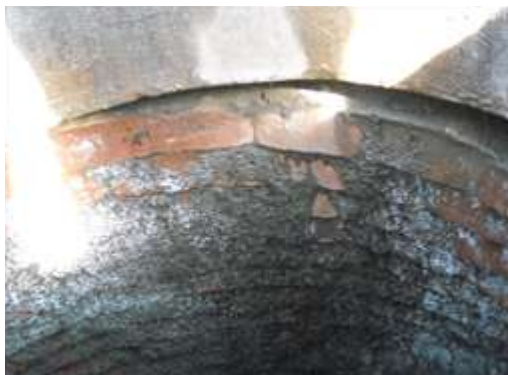
Defect 4

Frame Offset: **2** (in.) Condition: ☐ Sound ☒ **Cracked** ☒ **Leaks**

leaks between the corbel to the frame

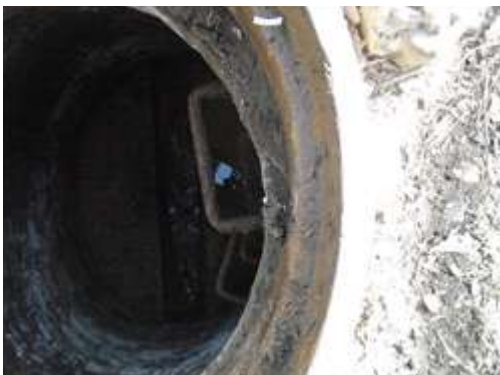
Defect 3

frame offset

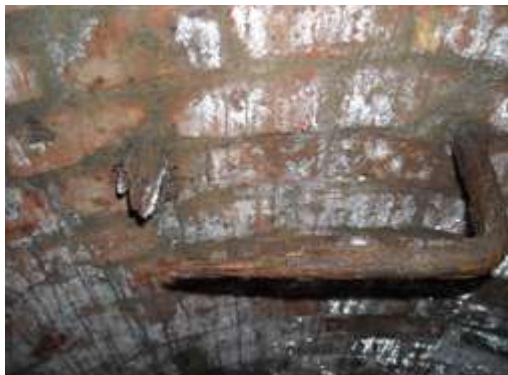
Defect 2

Steps Count: **4** Missing: **0** ☒ **Corroded**

corroded steps

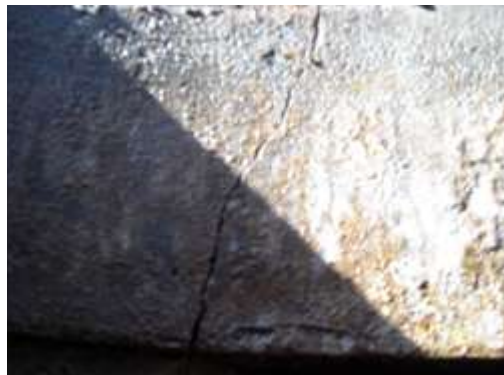
Defect 1

frame cracked

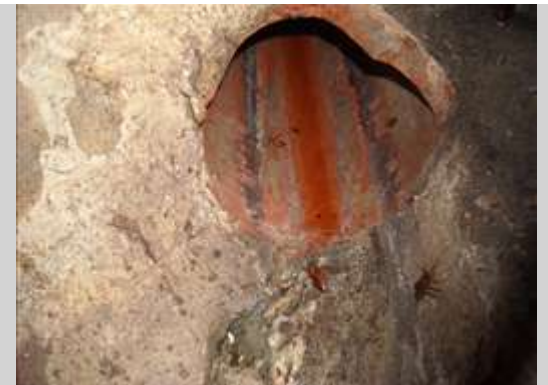
4 O'Clock Inflow

Pipe Height: **10.8** (in.) Rod and Bar (Angled)
Pipe Material: **Clay** ☐ Pipe Lined
Invert Depth: **7.22** (ft.) Flow Characteristics: **Slow**
Deposits: ☐ None ☐ Mud ☐ Sludge ☒ **Debris** ☐ Grease
Silt Depth: **1** (in.) Deposits Extent: **Light**
Infiltration: **None** Pipe Seal Cond: **Sound**
